Fits: GM 6T40/45 2008- UP

Brand new steel plates that have been designed by to save your 6T40/45, 4-5-6 Drum. Also includes an extra thin steel plate in case your piston hemline has worn out.

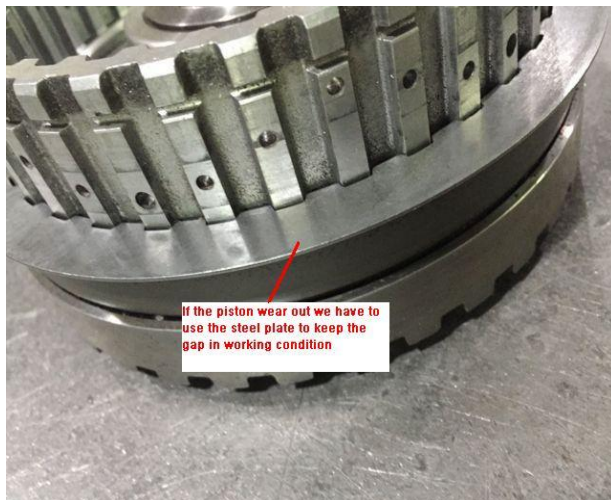
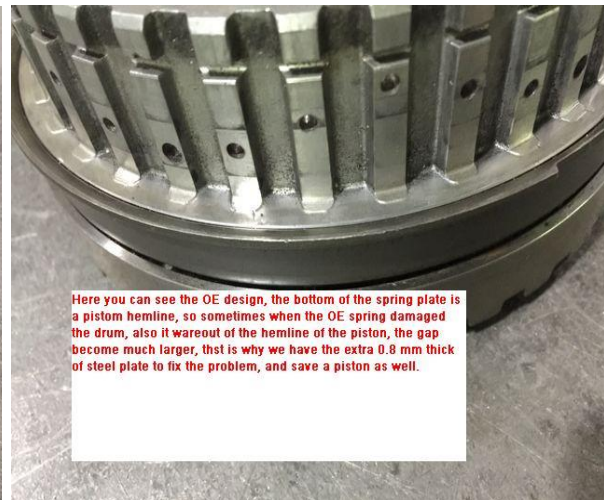
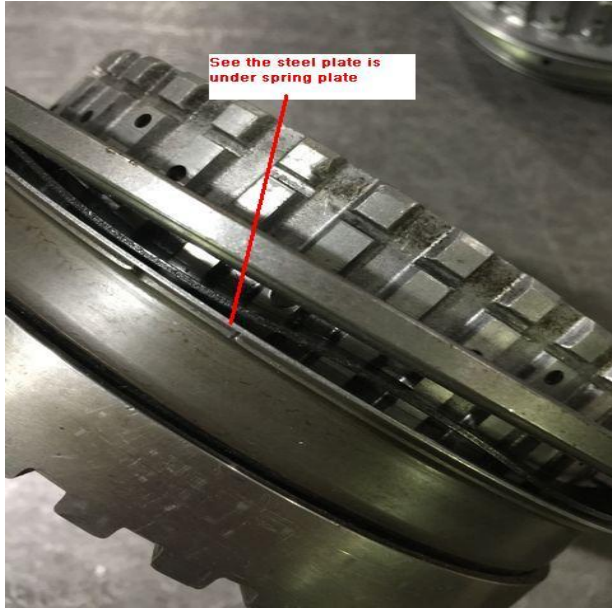
Step 1: Remove bottom waved plate and backing plate from damaged drum. You will notice these are the very last bottom plates.

Below you will find our solution to fixing the problem forever.

Step 2: After removal of OE Drum plates (Backing Plate and waved plate) place waved plate first and backing plate afterwards. This will cover damaged area and will fix the problem.

Step 3: Depending on wear and tear of piston hemline, you may use our 0.8 mm thin steel plate. If your piston hemline is not very worn out, there is no need for additional steel plate.

Step 4: You may then place the rest of frictions and steel plates as usual.
