Front Servo Piston Cover Kit

Part No.
22827-01

Chrysler 46RE, 46RH, 47RE, 47RH, 48RE, A727

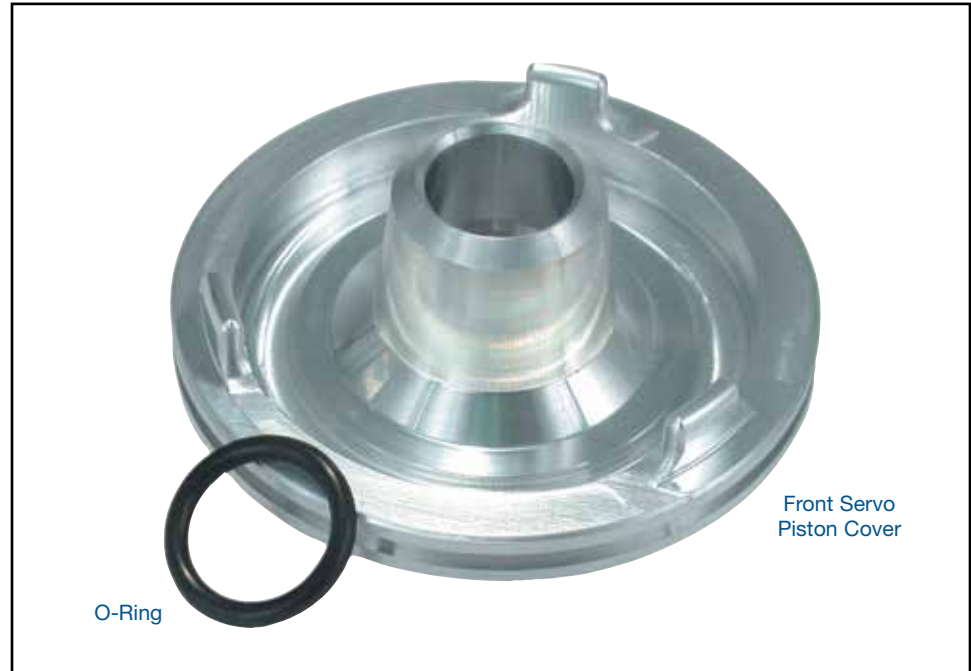
- Front Servo Piston Cover
- O-Ring

- Remove OE retaining ring and retain for reuse.
- Remove OE servo piston cover and discard.
- Buff off any servo pin scoring with 400-grit emery cloth followed by Scotch-Brite[®].

- Replace with Sonnax front servo piston cover with O-ring.
- Reinstall OE retaining ring.

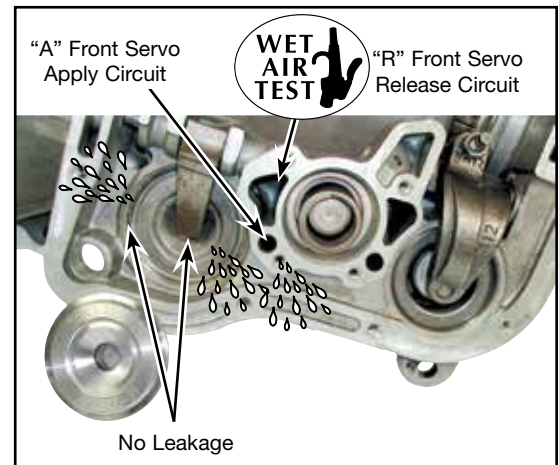
- Place a small amount of oil into the front servo release port "R" and follow with 30-40 psi of air pressure.
- Verify that there is no leakage at the servo cover.
- Oil leaking into the servo apply circuit indicates cross leakage at the servo piston. This means lost clutch oil and can result in direct clutch failure.
