## PRE-INSTALLATION CHECKS

## PROGRAMMING & DRIVE LEARN PROCEDURE

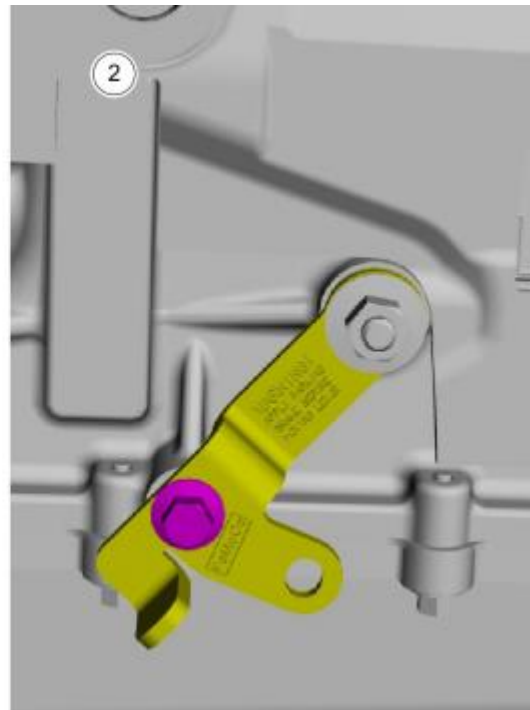
- Before transmission installation, verify the lever is secured to case with bolt in the lower lever slot (figure 1). This is for normal vehicle operation of the park locking system.
- If vehicle needs to be towed or service needed that would require manual release of park, apply parking brake first anytime vehicle is on the ground. Remove bolt and place lever in lower position and secure it with bolt through upper slot (figure 2).
- Bolt torque is 177 inch lbs.

**Only release park brake in this position if ready to tow or vehicle is on a hoist.**
