**Mitsubishi/Hyundai/Chrysler KM Series
Overdrive PowerPack® #059757 or
Overdrive PowerPack® w/Seal Kit #059935PWR**

INSTALLATION INSTRUCTIONS

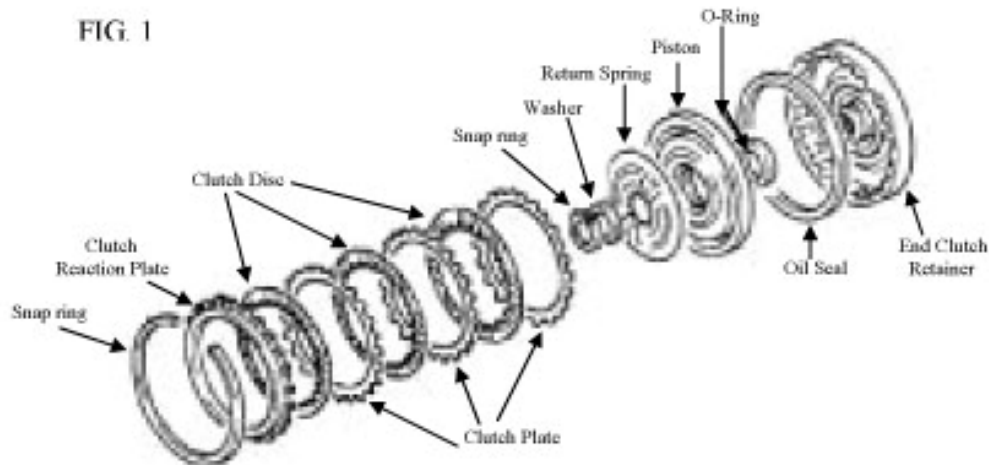
The stack-up of the overdrive clutch body is the same as the factory set-up. (See Fig.1) The clutch pack clearance should be between 0.6 and 0.85mm (.024" and .033"). To obtain the correct clearance, selective snap rings are available from Alto Products.

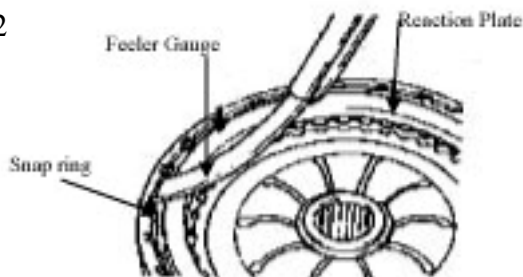
FIG 2

1. Assemble end clutch completely and apply clutch several times using air pressure (wet) to make sure all components are seated.
2. Push pressure plate towards piston.
3. Measure clearance between the snap ring and the pressure plate. (See Fig.2)
4. After determining the thickness of snap ring required, use the chart below to find the part number of the correct snap ring.

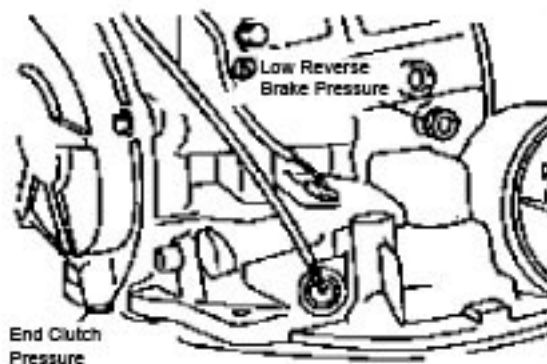
Figure 3

These transmissions experience many leaks in the end clutch apply circuits. It is always a good practice to check end clutch pressures after rebuild. For location of pressure tap, see Fig 3.
